The three approach to test the integrity of the perforated patch configuration

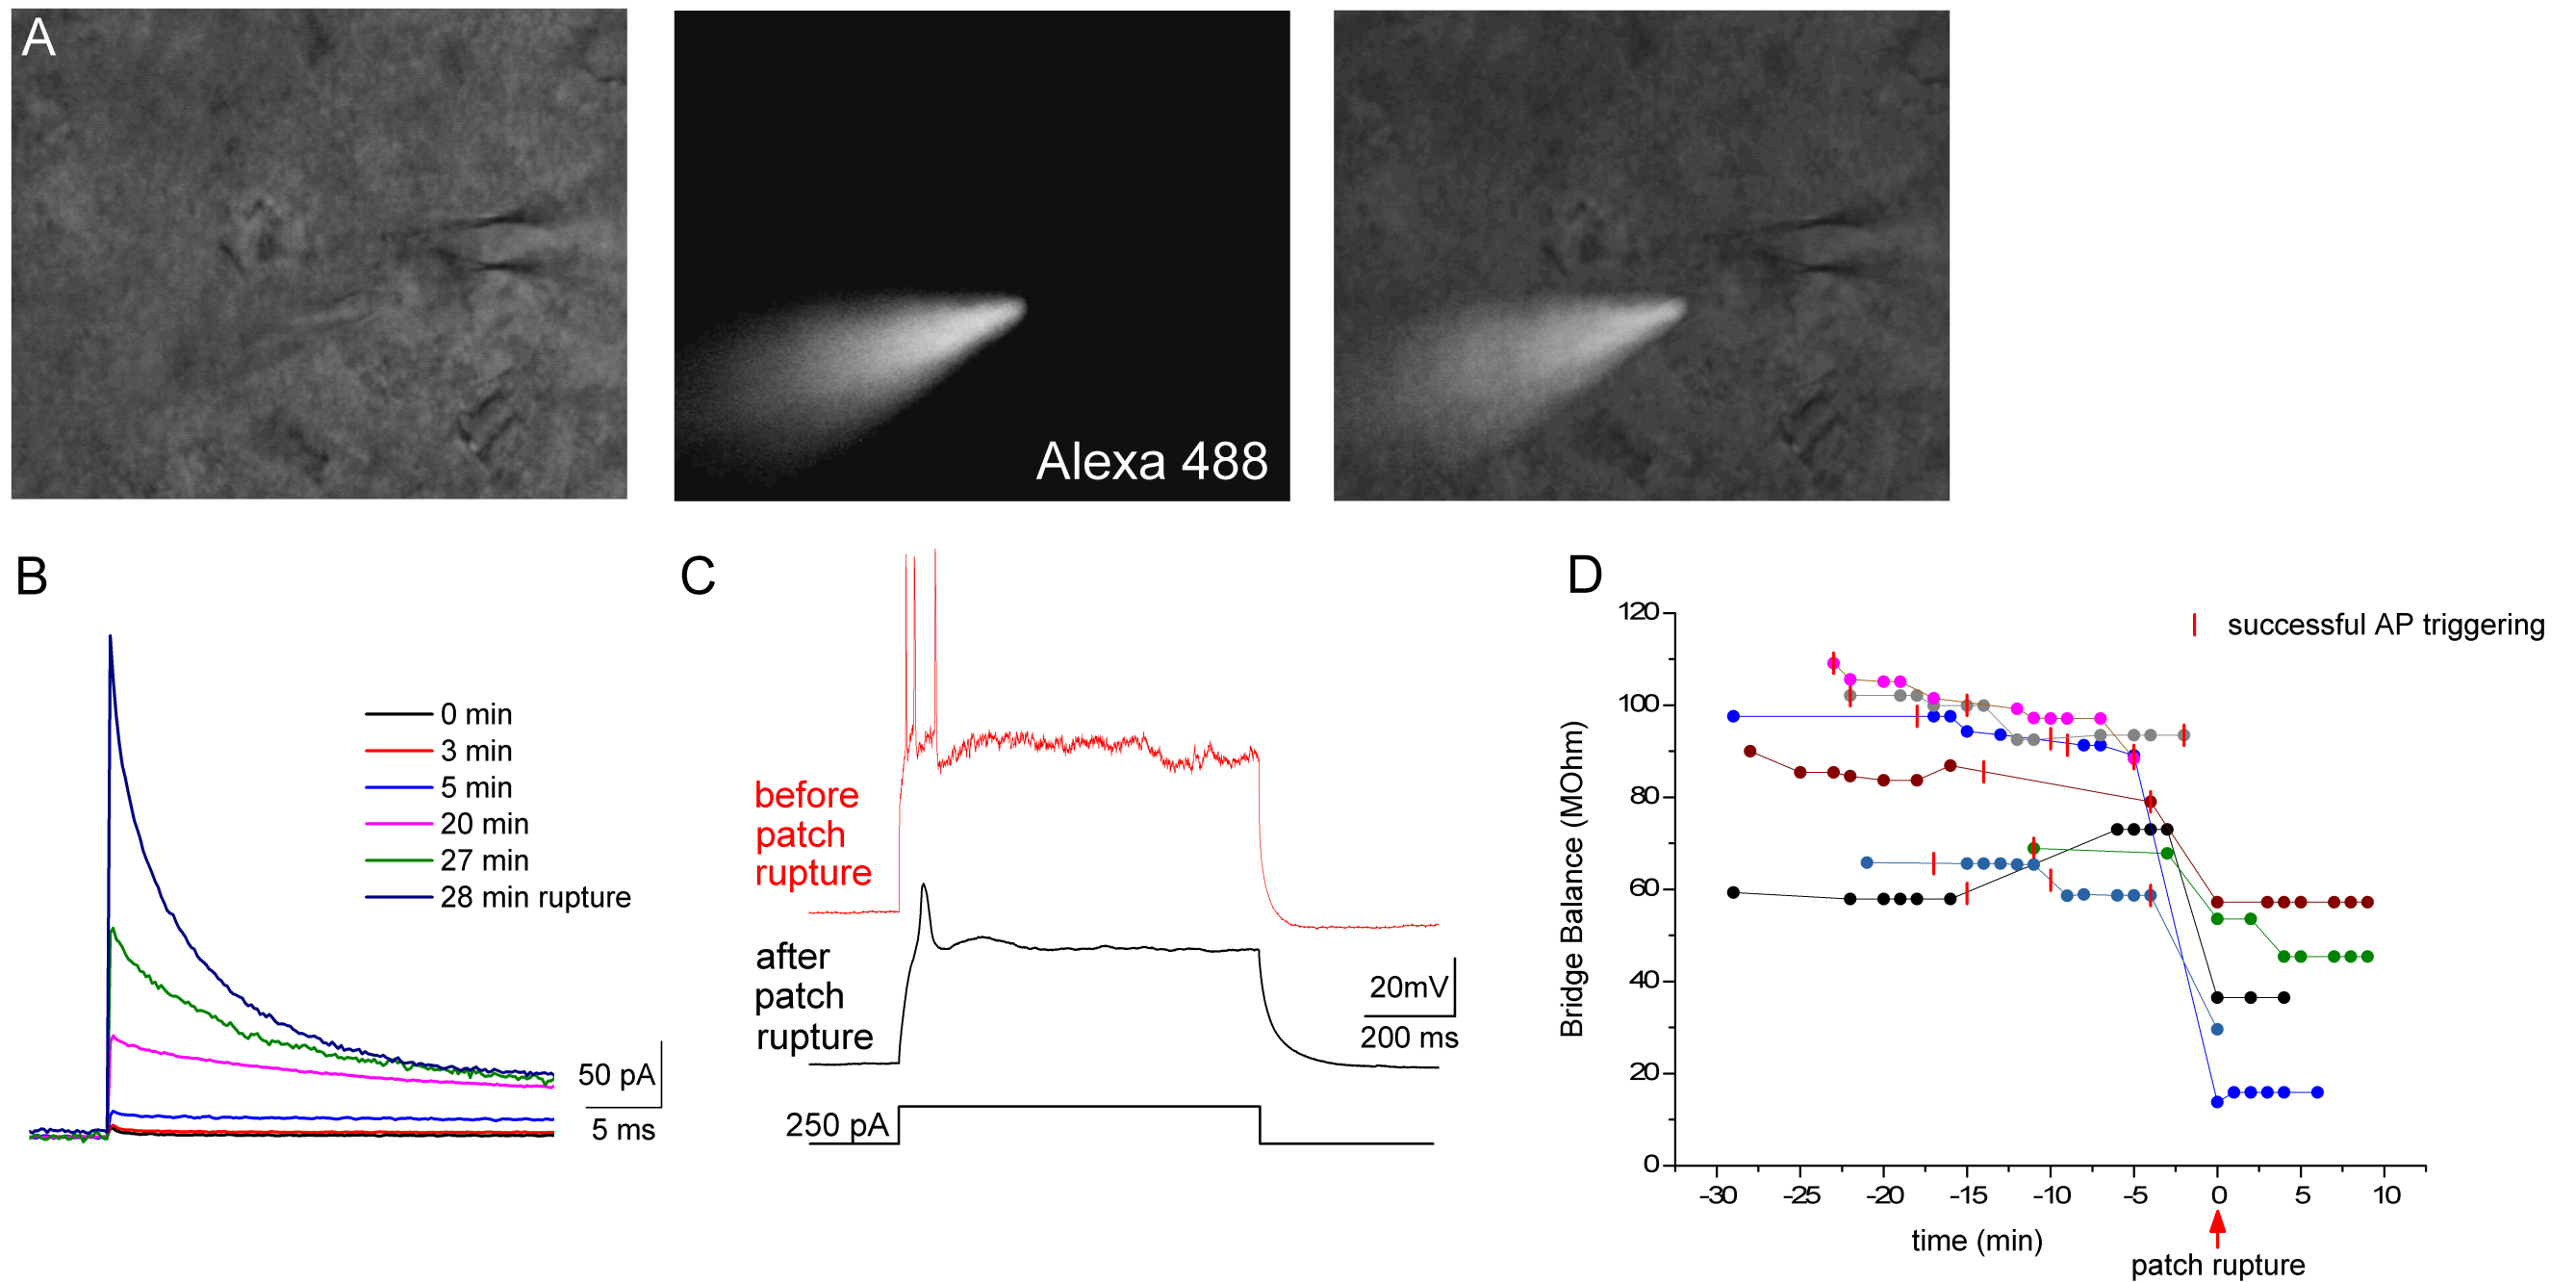
A, Presence of the Alexa488 in the recording pipette but not inside the cell was monitored throughout the recordings . B, The current changes in response to a depolarizing 5mV pulse (seal test) during a representative recording. Note the sudden increase in the current after the rupture of the perforated patch induced by negative pressure application. C, The cell capability to produce action potential in response to an intracellular current pulse injection was also tested throughout the recordings. Note the inability to firing after the rupture of the patch, in consequence of the QX-314 diffusion into the cell, a sodium channel blocker applied in the intracellular solution for the perforated patch recordings. D, Changes in the bridge balance values during the recordings, indicating the series resistance in current clamp mode. Each color represents a recorded pair (n=7), each dot represents a current clamp recording preceded by a Alexa488 test (see A). Red vertical lines represent a successful test for the firing ability of the recorded cell (see C). In two cases (magenta and grey) the cell didn't survive the rupture of the patch by negative pressure application.
